Cyclone Gabrielle Baseline Sampling 2023

An overview of data collected
following Cyclone Gabrielle
September 2023

Report prepared by Alex Dickson and Dan Bloomer (LandWISE Inc.), Alec Mackay (AgResearch), Alan Palmer (Massey University), Sally Anderson (Market Access Solutionz).

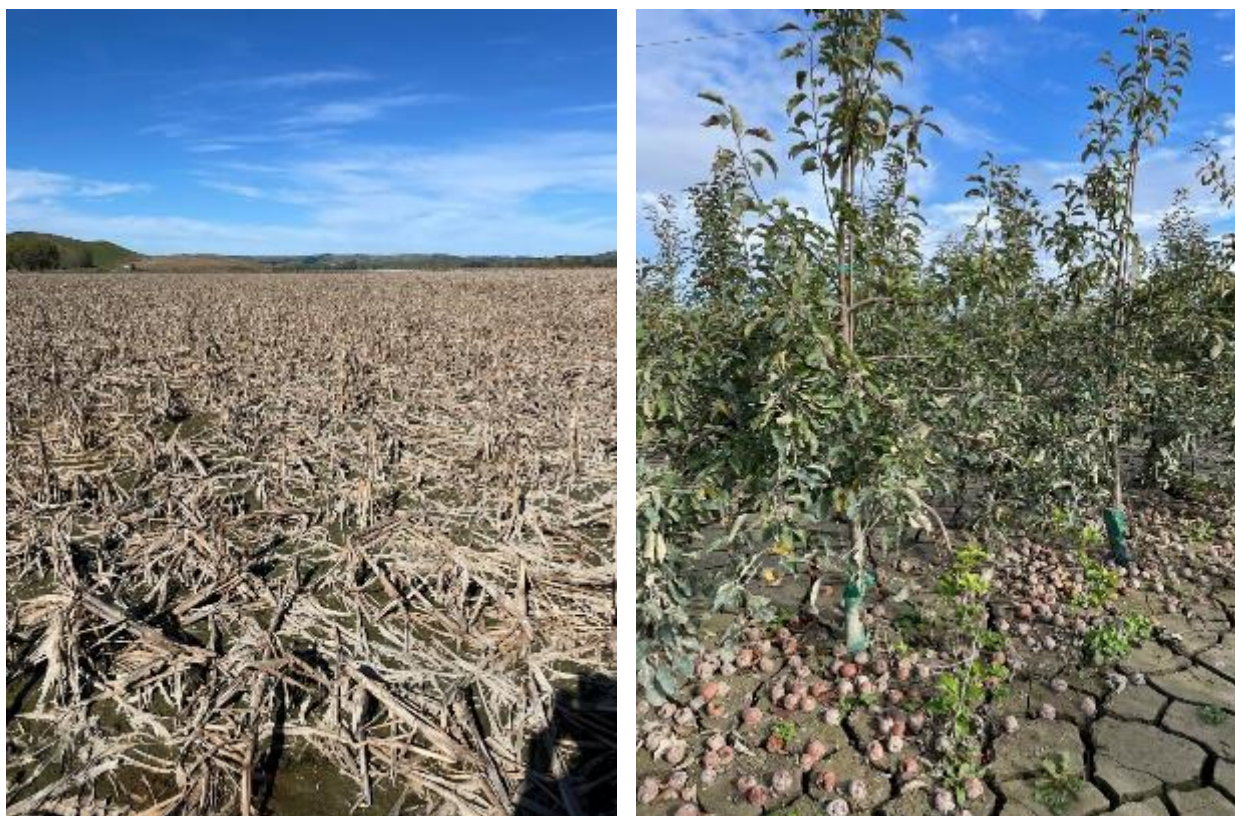
Figure 2 Examples of Hawke's Bay impacted areas: a sweetcorn paddock and an apple orchard.

Sampling in Hawke's Bay was led by LandWISE, supported by AgResearch, Massey University and Plant and Food Research. Over a three month period, 82 samples were collected across 60 sites, engaging with over 30 growers from across the region. The cyclone hit just before most fruit and vegetable crops were harvested. Some crops could be salvaged, but in many cases flood water either damaged the crop, buried it in sediment, or the edible part of the plant was inundated with flood water making it unsuitable for harvest.

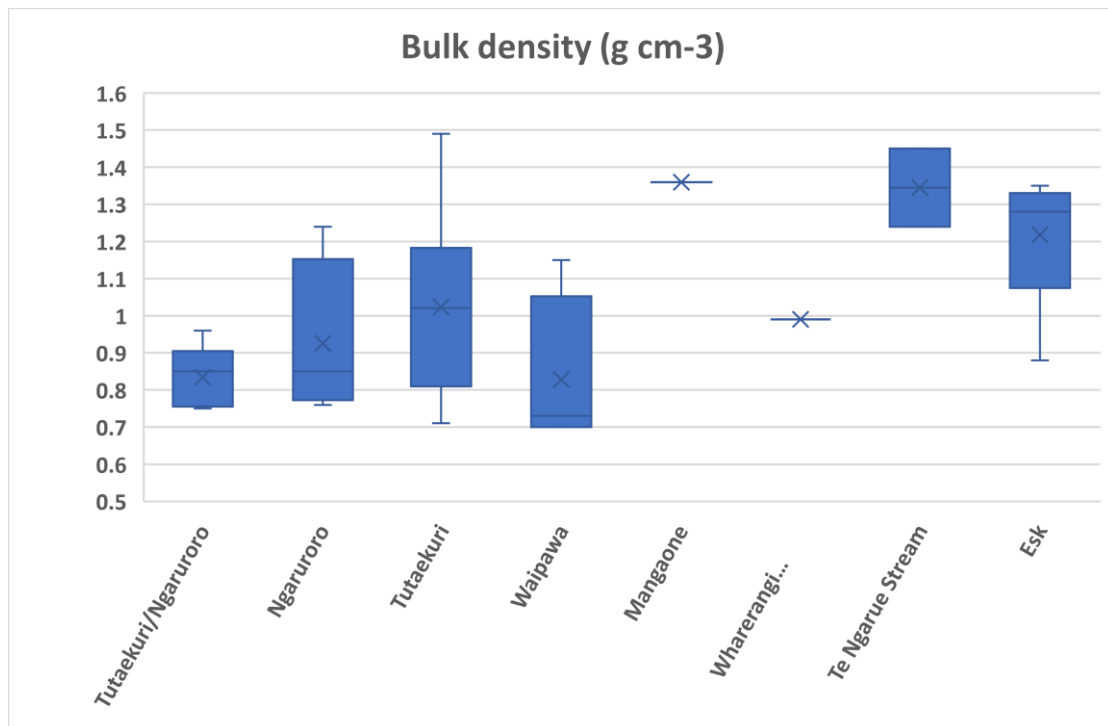
Figure 5 Bulk density of sediment samples (Hawke's Bay)

The bulk density of the sediment sampled in the Hawke’s Bay ranged from 0.70 to 1.49 g cm⁻³. Sediments sampled in the Mangaone, Te Ngarue stream and Esk catchments all had a bulk density value > 1.2 g cm⁻³ (Figure 5). This was associated with textures ranging from a fine sand, loamy fine sand, sandy loam, to fine sandy loam. This was also the case in the upper reaches of the Tutaekuri catchment. In the middle and lower reaches of the Tutaekuri and other four catchments, bulk density values ranged from 0.81 to 1.03 g cm⁻³ and textures of the sediment varied from a silt loam to a silty clay loam. As a guide, soil bulk density higher than 1.6 g cm⁻³ tends to restrict root growth. Sandy soils are more prone to high bulk density. (See Appendix 5: Notes on Bulk Density and Total Porosity)

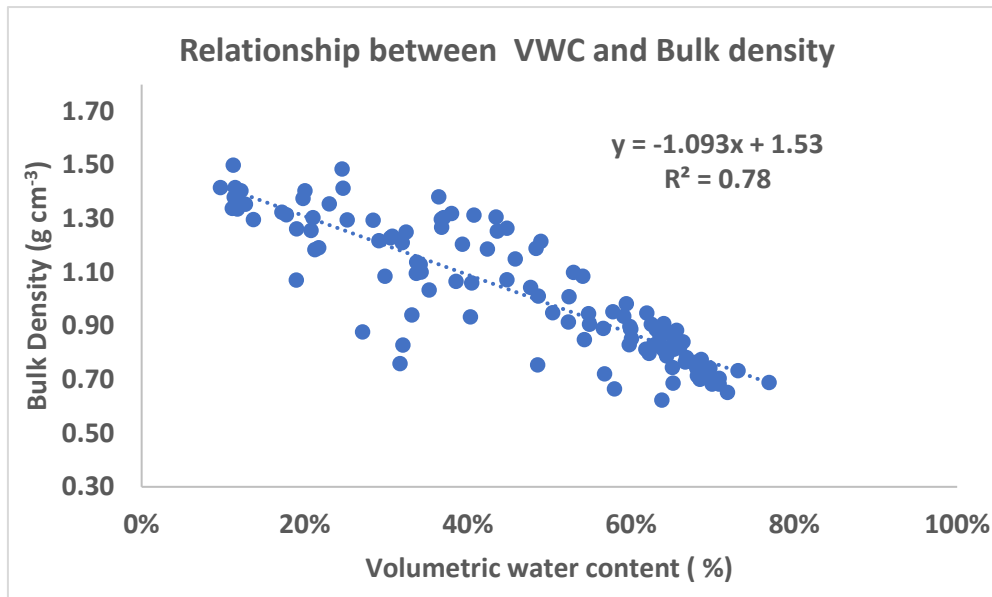
Figure 6 Relationship between volumetric water content and bulk density sediment samples (Hawke's Bay)

At the time of collection (33 – 80 days after the cyclone) the volumetric moisture content of the sediments sampled across the seven catchments within Hawke’s Bay varied from 11 – 80%. The volumetric moisture content of the sediment at the time of sampling was highly correlated with the texture of the sediment (Figure 6 Relationship between volumetric water content and bulk density sediment samples (Hawke’s Bay)). For example, the volumetric moisture content of the sediment collected from the Mangaone, Te Ngarue stream, Esk and upper reaches of the Tutaekuri catchments ranged from 12 – 33%, while the volumetric moisture content from samples from the middle and lower reaches of the Tutaekuri and other four catchments ranged from 43 – 61%. As sediment drains, particles slowly collapse, filling voids, and increasing the mass of material collected within a given volume.

Scatter in the data may be due to the origin of the parent material containing different amounts of volcanic glass and organic matter, both of which will lower bulk density. In considering the effect of the physical properties of the sediment on plant growth, water infiltration, etc., bulk density, particle density and the porosity of the sediment have influence. The particle density of the coarse textured sediments (fine sand through to a loamy fine sand) which averaged 2.65 gm cm^{-3} was higher than the finer textured sediments (silt loam, silty clay loams) which averaged 2.48 gm cm^{-3} fine sandy loam. Most quartzo-feldspathic rocks such as greywacke, sandstone and mudstone are dominated by quartz and feldspar with specific gravities of 2.65 and $2.55\text{-}2.63 \text{ g cm}^{-3}$, respectively. Sediments and soils with appreciable organic matter can have lower particle density because organic matter is generally in the range $0.8 - 1.1 \text{ g cm}^{-3}$.

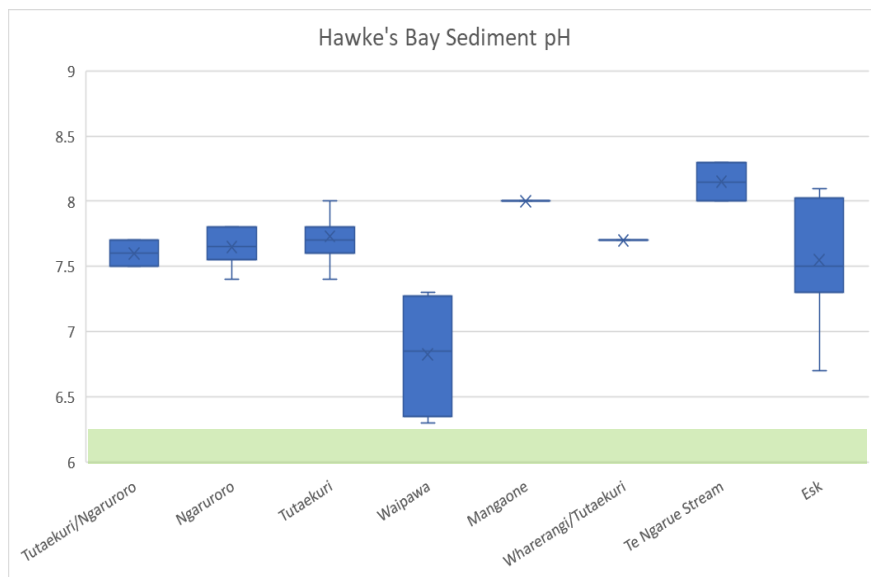
Figure 7 Hawke's Bay sediment pH results by catchment

The pH of most sediment samples is elevated above the optimum range (Figure 7). This has been raised as an area of concern for nutrient availability in some crops. Outside of the optimum range, pH can lead to reduced availability of some macro and trace elements. The Waipawa samples had lower pH's, possibly due to a higher level of topsoil from upstream sites being included in the sediment samples. The source parent material (Whangai shale or Waipawa siltstone) also tends to be more acidic.

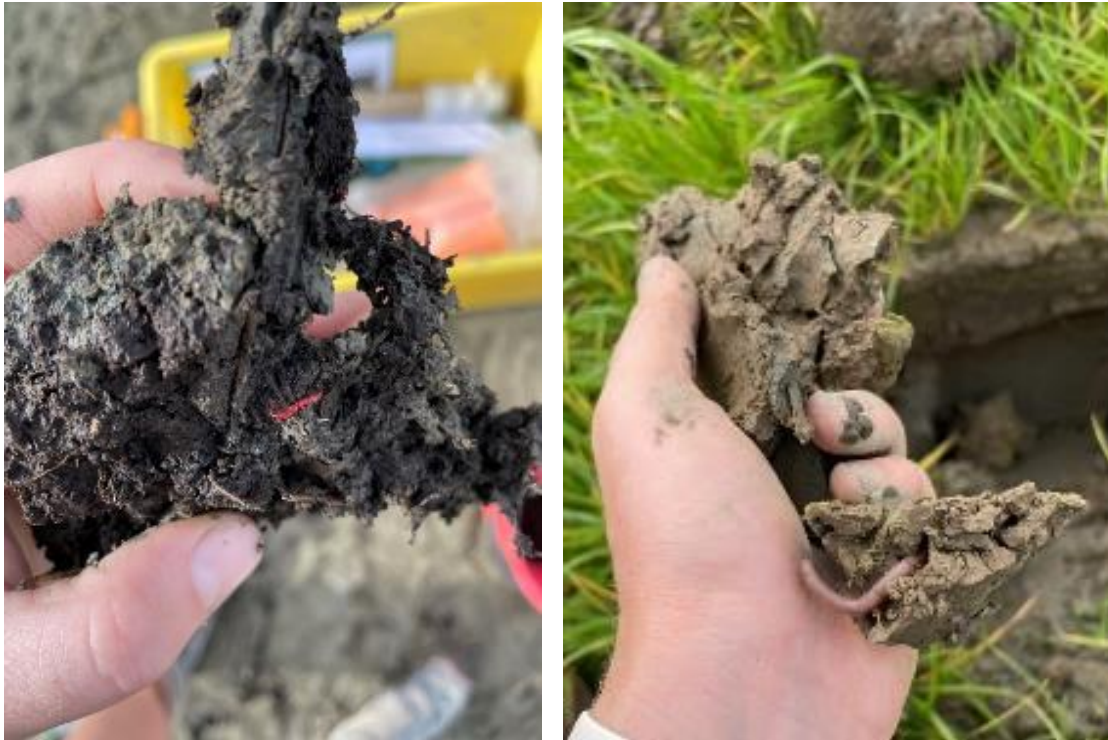
Figure 16 Earthworms found in Hawke's Bay samples

"The most common earthworm detected was endogenic Aporrectodea caliginosa, this species is the most common species found in agricultural soils in New Zealand. Endogenic species burrow extensively throughout the topsoil and form semi-permanent burrows. Other endogenic species found include Aporrectodea rosea and Aporrectodea trapezoides. Lumbricus rubellus was also found, this is an epigenic earthworm which decomposes organic matter on the soil surface, with another epigenic species, Eisenia andrei also found. Deeper burrowing anecic earthworms consisted of Aporrectodea longa. Native earthworms were also observed at two sites (#63 and 76).

Average earthworm abundance was low across all sites. Abundance tended to be lower at sites with > 20cm of sediment, these also had the smallest percent of samples with earthworms. The highest abundance of earthworms tended to be found on < 5cm of sediment, with the highest percent of samples with earthworms present in samples with no sediment."

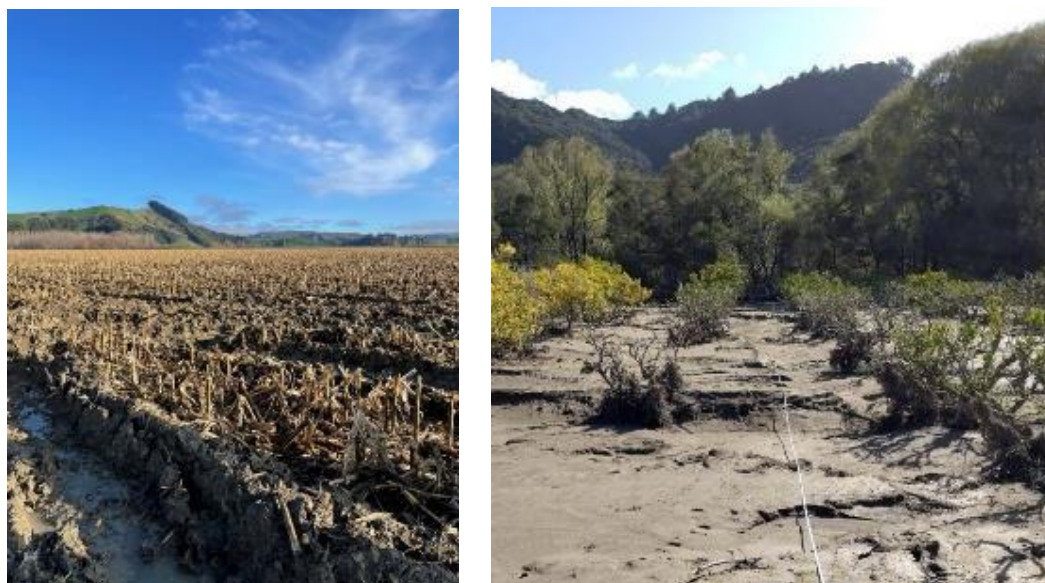
Figure 17 Gisborne impacted areas: a maize paddock and a citrus orchard

three months, 55 samples were collected across 30 sites, engaging with over 22 growers from across the region. There was considerable impact to many crops including maize, squash, citrus, apples, and kiwifruit, as well as in the hill country. Cyclone Gabrielle came after two years of wet conditions, and the northern East Coast had already suffered several major weather events. There was already pressure on the region's people, crops and soils.

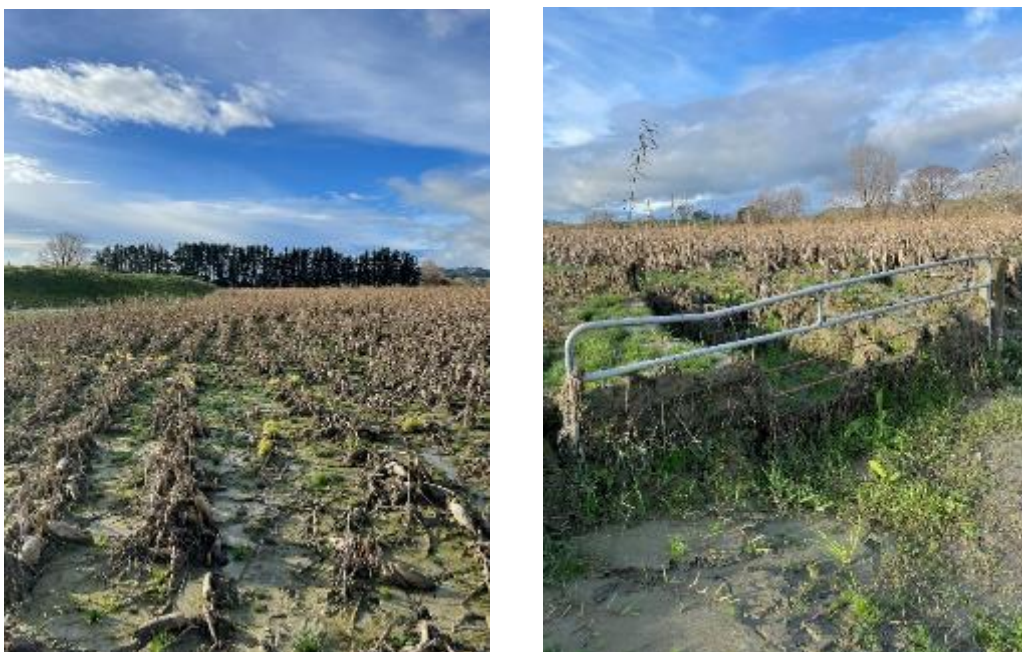
Figure 28 Wairoa impacted areas: maize paddocks.

Cyclone Gabrielle followed two previous very wet years, with Wairoa having been hit with several major weather events. The impacted flats are an important part of many farm systems in the area, providing feed for winter grazed stock.

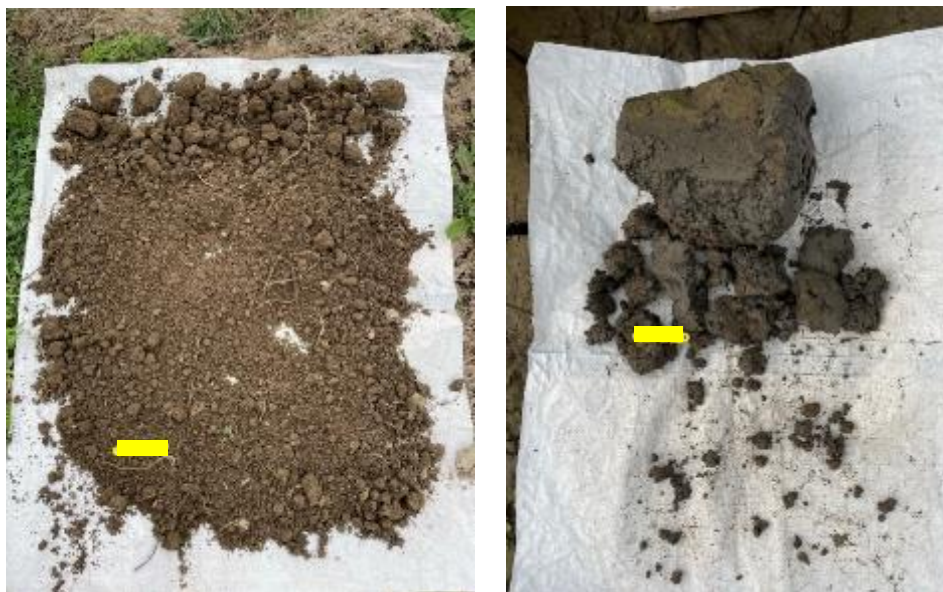
Figure 46 Examples of Visual Soil Assessment Results

Three VSAs were completed along each transect as an assessment of the sediments' "soil quality". Where sediment depth was less than 20cm, the test included some underlying soil. The soil conditions in which these VSAs were completed was not ideal, as the samples were very wet, however useful information was captured from the process and baseline photos taken. See Figure 46 for two examples of VSAs from different sites.

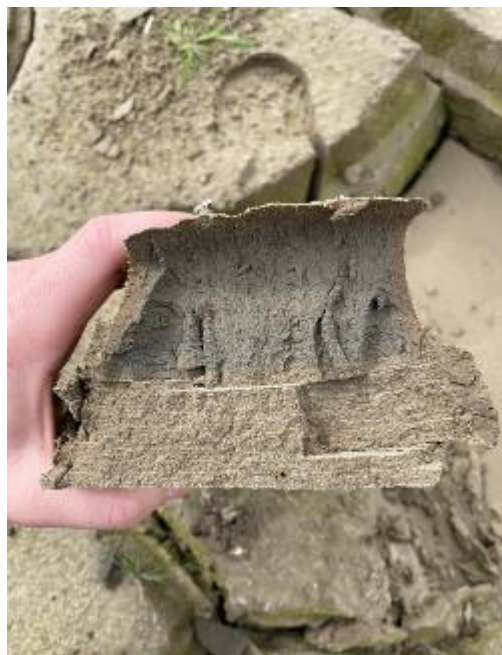
Figure 50 Example of two sediment deposits on one site

at the higher reaches of a river where water velocity is fastest and as water movement slows, more of the silt, then clay, fractions will be deposited. Sediment texture is an important factor for growers to consider in recovery efforts, as it is likely to influence nutrient content, moisture content and revegetation options. Textural samples were taken from each site and sent to Dr Alan Palmer at Massey University for analysis. In some situations there were two distinct layers of sediment deposited, in which case two samples were sent to be analysed.
